NATIONAL TRANSPORTATION SAFETY BOARD
WASHINGTON, D.C.

STRUCTURES GROUP CHAIRMAN'S FACTUAL REPORT OF INVESTIGATION

A. ACCIDENT : DCA-94-MA-076

LOCATION : Aliquippa, PA
DATE : September 8, 1994
TIME : 1904 Eastern Daylight Time (EDT)
AIRCRAFT : Boeing 737-3B7, N5 13AU

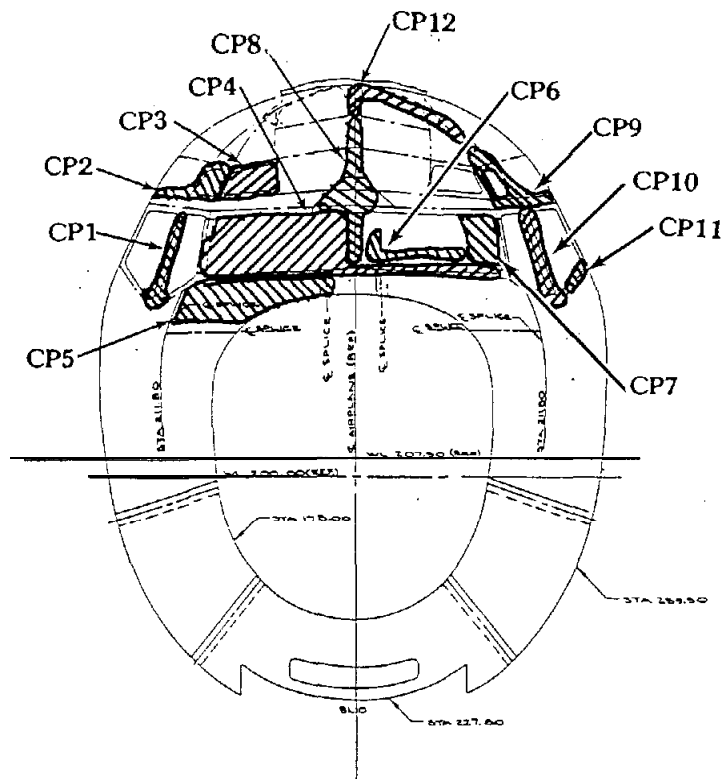
VIEW LOOKING AFT

The cockpit structure was severely fragmented. The following view of the cockpit structure shows the areas that were identified:

Cockpit (CP) support posts CP-1, -10, and -11 exhibited compression damage along the posts. CP-2, -3, -4, and -5 exhibited compression damage surrounding the window framing and also exhibited overload fractures at the forward and aft window posts, with a windshield wiper arm remaining attached to the CP-5 support and the CP-4 window attached and shattered. CP-6, -7, -9, and -12 sustained postimpact fire damage, and CP-8, -9, and -12 exhibited compression damage.
